DEPARTMENT OF TRANSPORTATION

Quality Assurance and Source Inspection

Contract #: 04-0120F4Cty: SF/ALA Rte: 80 PM: 13.2/13.9File #: 1.28**WELDING INSPECTION REPORT****Resident Engineer:**Siegenthaler, Peter**Address:** 333 Burma Road**City:** Oakland, CA 94607**Report No:** WIR-026055**Date Inspected:** 13-Aug-2011**Project Name:** SAS Superstructure**OSM Arrival Time:** 700**Prime Contractor:** American Bridge/Fluor Enterprises, a JV**OSM Departure Time:** 1530**Contractor:** American Bridge/Fluor Enterprises, a JV**Location:** Job Site

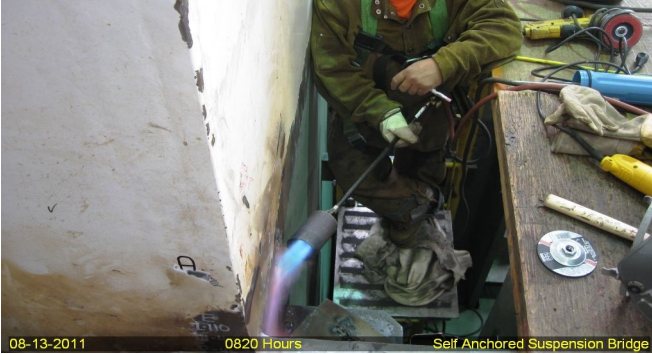
At Tower Base Elevation 13Meters, Electro Slag Welding (ESW) T-joint #N-045 location 'E', ABF welder Jorge Lopez was noted preheating the excavation and adjacent base metal to more than 300 degrees Fahrenheit prior the 2nd time welding repair.

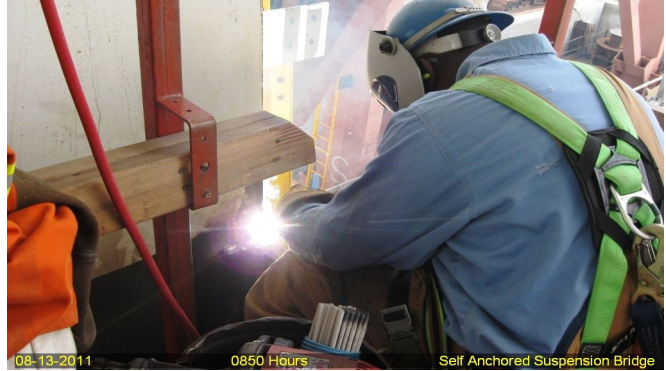
At Tower Base Elevation 13Meters, Electro Slag Welding (ESW) T-joint #W-041 location 'W', ABF welder Fred Kaddu was observed performing 2G Shielded Metal Arc Welding (SMAW) welding repair.
